Reference project

**Industrial cooling units
 automotive plant / paper mill**

Cleaning of industrial cooling units in an automotive plant and in a paper mill

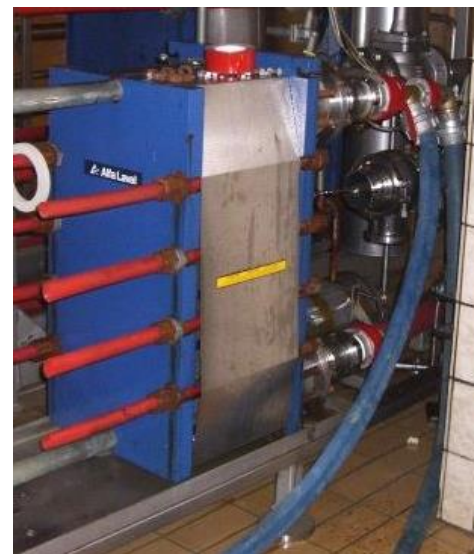
Figure 2: gasketed plate heat exchanger

- cleaning of gasketed plate heat exchangers (Figure 2)
- cleaning of 7 heat exchanger in two industrial sites during regular shutdown
- biofilm deposits
- last cleaning procedure performed only a year ago
 → few deposits and low measurability expected

- heat exchangers with 128 to 220 plates
- inner volume of chambers: 111 to 133 L
- distance to Comprex® unit: between 20 and 70 m
