Reference project
Cooling lubricant system
Automotive supplier

Cleaning of a cooling lubricant supply system

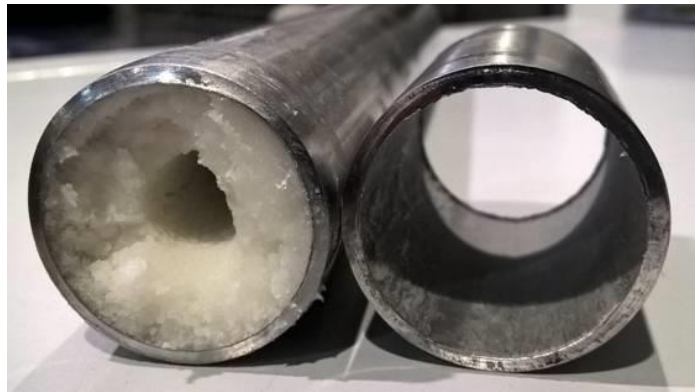
Figure 1: pipeline for cooling lubricant before cleaning (left side) and after cleaning (right side)

- clean central cooling lubricant supply lines with the Comprex® process
- remove deposits of lime soap (Figure 1) from the system
- recover performance and operational safety of the system

- deposits (mostly lime soap) mobilized and discharged from the cooling lubricant system (Figure 4)
- improved hydraulic performance
- original diameter of pipeline recovered (Figure 1)
- full capacity of the system is recovered
- efficient, safe and reliable operation

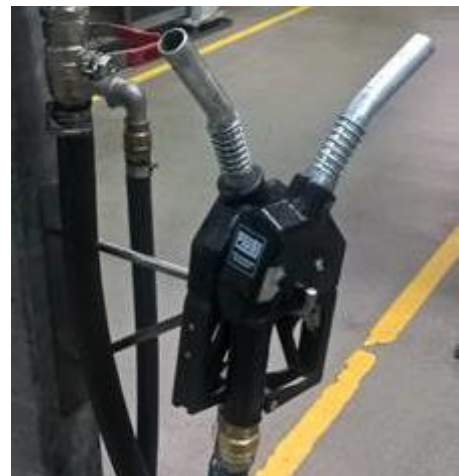
- cooling lubricant supply system with 39 taps (Figure 2)
 - length approx. 300 m
 - diameter 1 inch
 - material stainless steel
 - permitted pressure of the system approx. 5 bar

Figure 2: taps of the cooling lubricant-system

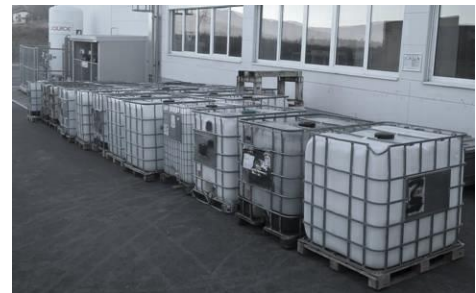
- mechanical cleaning by defined application of compressed and purified air from the Comprex® unit
- access to the system via standard adapters
- discharge of rinse water and deposits via the taps in provided containers (IBC) for simple discharge (Figure 3)
- 2 technicians, approx. 20 hours on site
- support by technical staff of the customer

Figure 3: discharge via IBC

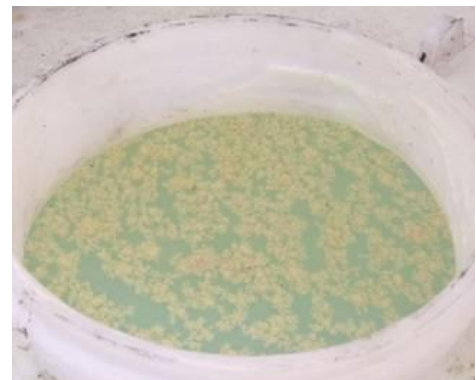
Figure 4: discharged deposits of lime soap
