Reference project

**Industrial cooling units
 automotive plant / paper mill**

Cleaning of industrial cooling units in an automotive plant and in a paper mill

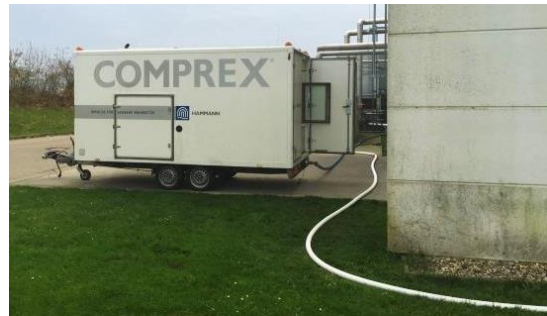
Figure 1: Comprex® unit at work

Cleaning using the Comprex® process

- cleaning: ½ day incl. setup time per heat exchanger
- assessment of success by characteristic curves or temperatured before and after cleaning
- 4 heat exchangers at 18 m level above the Comprex® unit next to the building
- 2 technicians / engineers, 1 Comprex® unit
- 2 heat exchangers per day

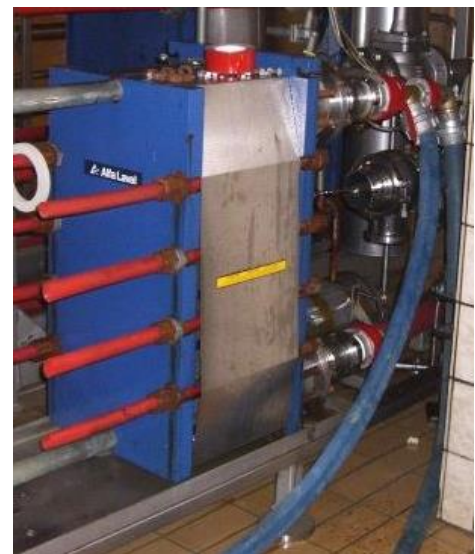
Figure 2: gasketed plate heat exchanger

- cleaning of gasketed plate heat exchangers (Figure 2)
- cleaning of 7 heat exchanger in two industrial sites during regular shutdown
- biofilm deposits
- last cleaning procedure performed only a year ago
 → few deposits and low measurability expected

- heat exchangers with 128 to 220 plates
- inner volume of chambers: 111 to 133 L
- distance to Comprex® unit: between 20 and 70 m

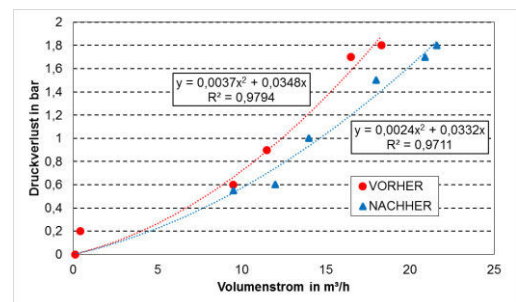
Figure 3: characteristic curve of heat exchanger before and after cleaning (pressure drop vs. volumetric flow rate)

- hydraulically (Figure 3) and thermally (Figure 4) measurable success of cleaning (Example „HE1“ and „HE2“ Heating-(H) and Cooling-(C)-side)
- pressure drop has been reduced significantly
- decrease of performance demand of 15 %
- **conclusion:** regular cleaning is a good strategy to prevent strong ageing of deposits; similar standard assignments in various industries.
