Cleaning of a municipal drinking water network in South Tyrol

Task

- cleaning the drinking water network of a community in South Tyrol (Italy) using the Comprex® process
- removing deposits
- eliminating problems with turbidity during supply
- ensure performance of the pipes

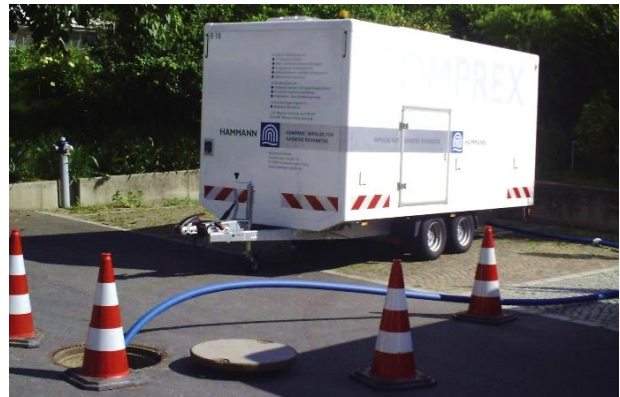
Figure 1: Comprex® equipment on site

- mechanical cleaning procedure using water and treated compressed air supplied by Comprex® unit (Figure 1)
- cleaning in sections via different injection and discharge locations of the pipe network
- access using adapter connections
- inspection glass for visualisation of cleaning progress (Figure 3 and Figure 4)
- 2 technicians, 7 days on site

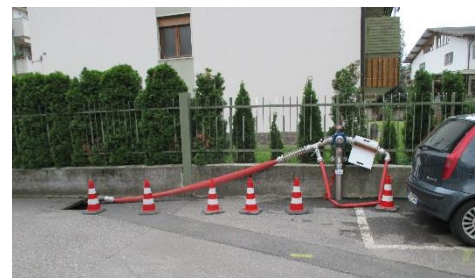
Figure 2: discharge location

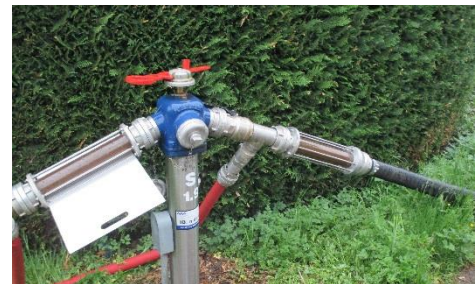
Figure 3: discharge using hydrant with inspection glasses

- deposits mobilised and discharged (Figure 3 to Figure 5)
- water supply without turbidity
- improved hydraulic properties due to decreased pressure drop
- performance and security of supply restored

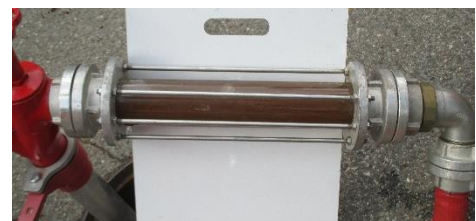
Figure 4: turbidity in inspection glass during cleaning

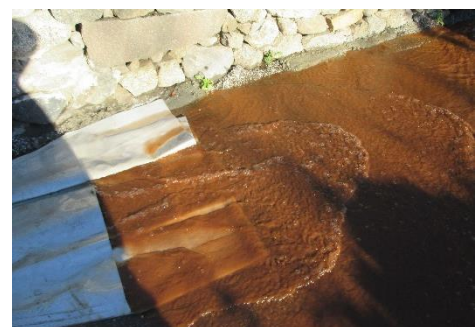
Figure 5: cleaning water with turbidity at discharge location
