Cleaning of the domestic installation optimized permanent disinfection

Hans-Gerd Hammann,
Kai Birnbaum, Annweiler

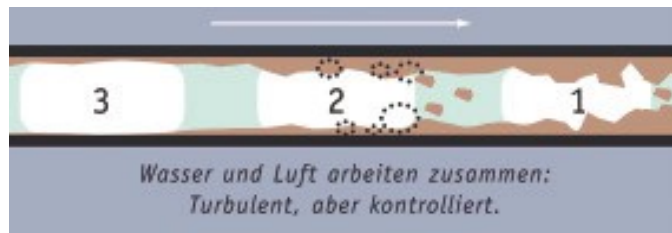
Picture 1

Functional principle of the pulse Rinsing process Complex

The Complex pulse flushing process is based on a controlled, pulse-like addition of compressed, pure air within a defined flushing section (Fig. 1). The important thing here is that precisely metered blocks of air are forced into the throttled water flow. These correspond to the diameter of the pipe. Very strong turbulent flows of approx. 10-15 m/s are generated around them, which are capable of destroying the laminar sub-layer of the water flow. In combination with cavitation shear, shear and drag forces, they cause all mobilizable deposits to detach from the pipe walls. The air pigs, the water and the deposits discharged through the tapping points are released and discharged by cyclone separators. Solid cover layers are not attacked and remain in the system. To prevent damage to pipe systems, some of which are quite old, the impulse pressure always remains below the resting pressure of the pipe network.

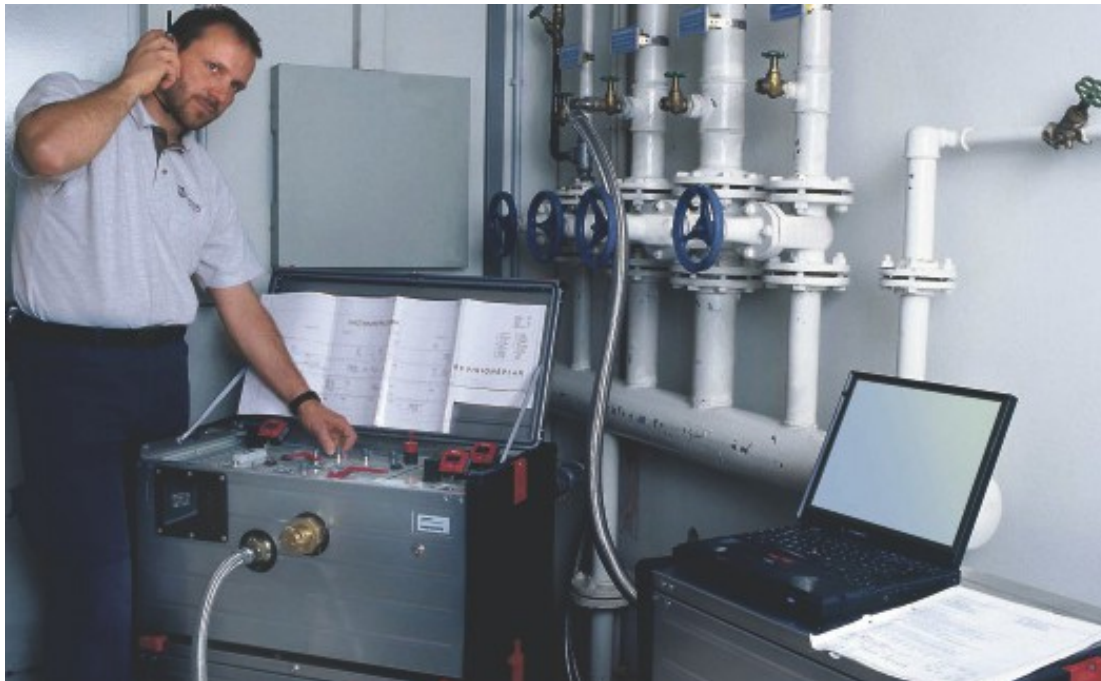
Picture 2

The air pulses are fed into the domestic installation via the distribution battery

The work to clean the drinking water The work on the cold water system began on schedule after Christmas. Before the actual flushing measure, it was necessary to carry out various conversion measures, but above all to prepare the two cold water distributors for feeding in the air (Fig. 2). In addition, the existing kitchen line had to be

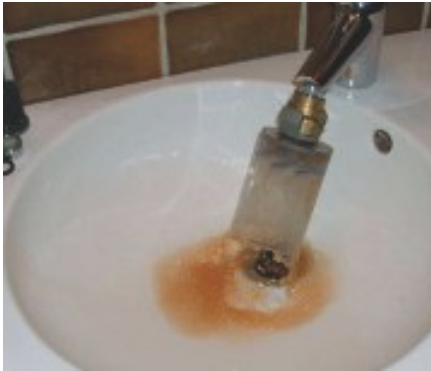
Picture 3

A long-lasting turbidity was observed during rinsing

After completion of the preparatory The actual cleaning work could then begin. A systematic approach is always taken. In this example, the taps and pipes were cleaned from the upper floor to the basement. The flushing fittings on the end pipes were now used to remove all deposits and biofilms from the basement distributions and risers, which were removed using the Complex process, from the system. This was carried out in both the cold water and hot water systems. During flushing, a long-lasting turbidity was observed in conjunction with the discharge of particles up to 2 mm in size (Figures 3 and 4).
