## Operating old drinking water installations without rusty water

Although no longer state of the art, many old hot water pipes are still made of steel. Replacing the old steel pipes is often not feasible in a timely manner in many buildings. To get the problems under control nevertheless, a combination of mechanical cleaning using the Complex process and subsequent dosing of corrosion inhibitors is recommended. This can significantly extend the service life of the drinking water installation until it is replaced at a later date.

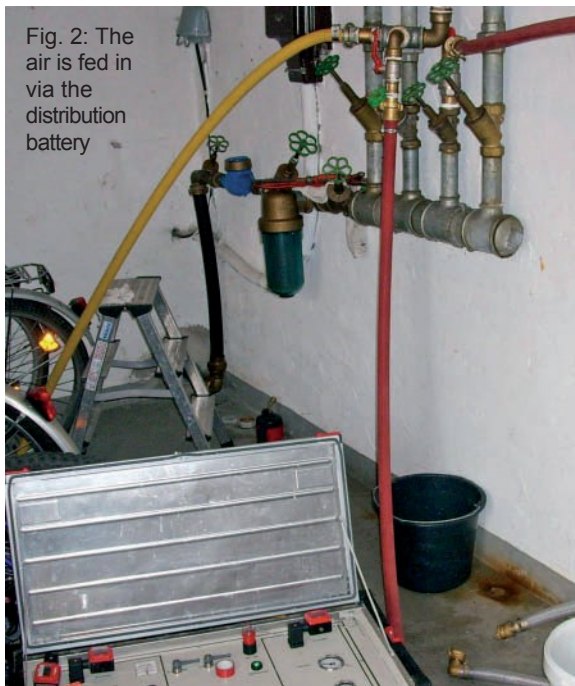
Fig. 2: The air is fed in via the distribution battery

The impulse flushing process is particularly suitable for cleaning existing installations. It is based on a controlled, pulsed addition of compressed, pure air within a defined flushing section (Fig. 1 + 2). The important thing here is that precisely metered blocks of air are placed in the throttled water flow. They flow through, the diameter

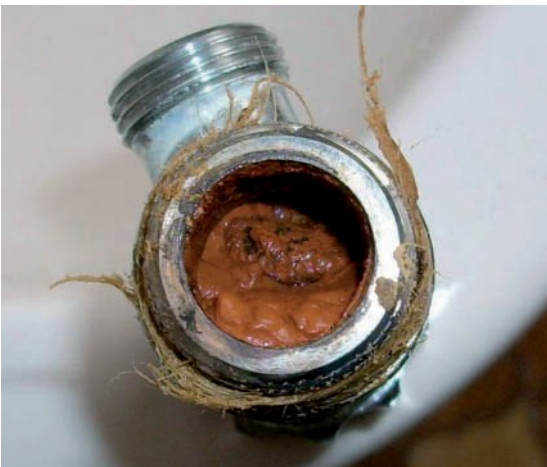
▼ Fig. 4: Angle valve clogged with corrosion products

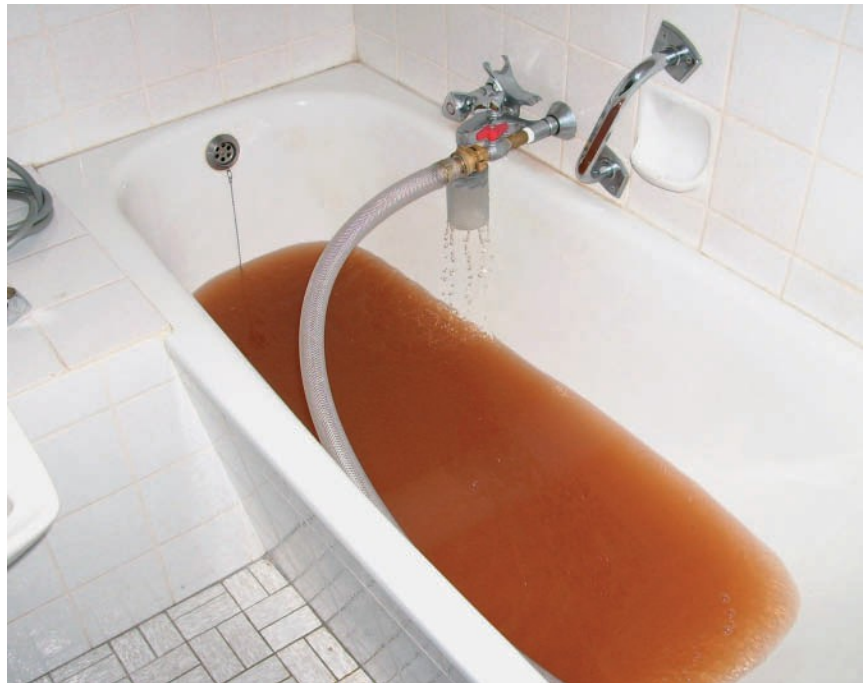
► Fig. 5: Due to massive leaks, many bathtub fittings had to be removed and replaced with flush fittings.

The assessment resulted in a workload of approx. two working weeks with a 3-man team. This was due to the number of sanitary objects with a total of 217 cold water/120 hot water taps and the expected high discharge of corrosion products and turbidity. Cleaning proved to be extremely time-consuming due to the already very advanced corrosion. There were massive deposits of rust up to 8 millimetres in size. Many fittings had to be dismantled and replaced with flushing fittings (Fig. 5).
