Experience with Comprex netcare at Stadtwerke Steinfurt

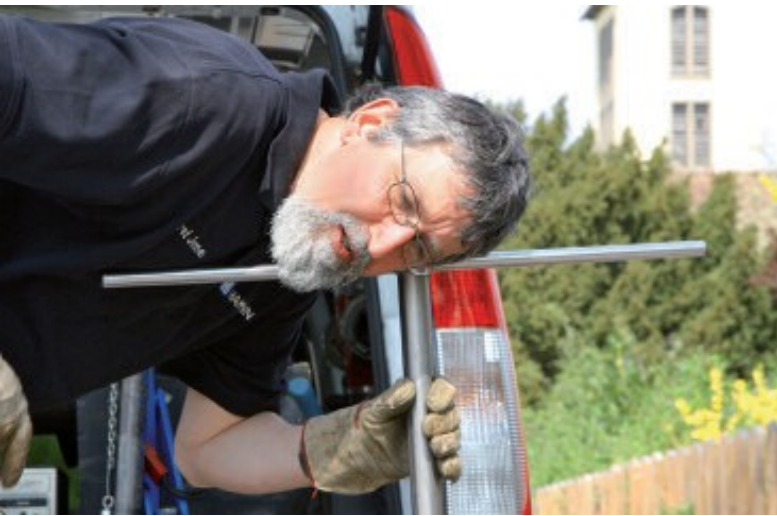
Fig. 1: Listening to a gate valve

Most gate valves are open during mains operation. Deposits can build up in the valve body and impair its functionality, causing the valves to close insufficiently or not at all. DVGW Code of Practice W 392 describes the valve inspection. However, the actual shut-off function cannot be determined in this way (Fig. 1). It is only possible to check the shut-off function when the pipe is out of operation, for example before cleaning the pipe network using the Comprex method.

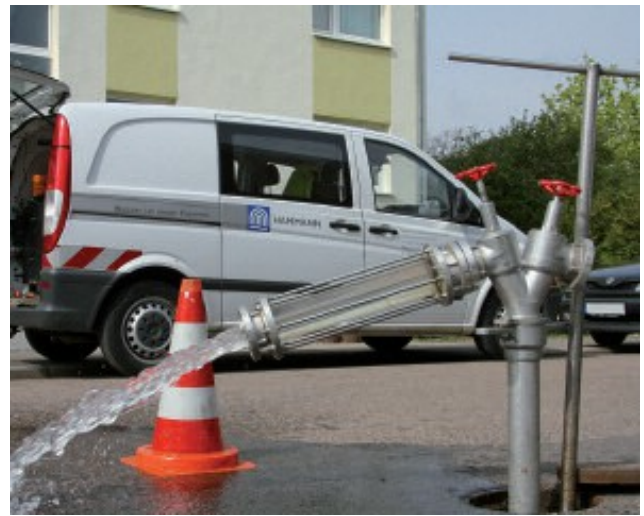
Fig. 2: Non-closing gate valve, recognizable by the water leakage

hydrants, it is possible to determine whether all actuated gate valves close tightly based on the water discharge. Valves that do not close or close poorly are detected (Fig. 2) and marked (Fig. 3).

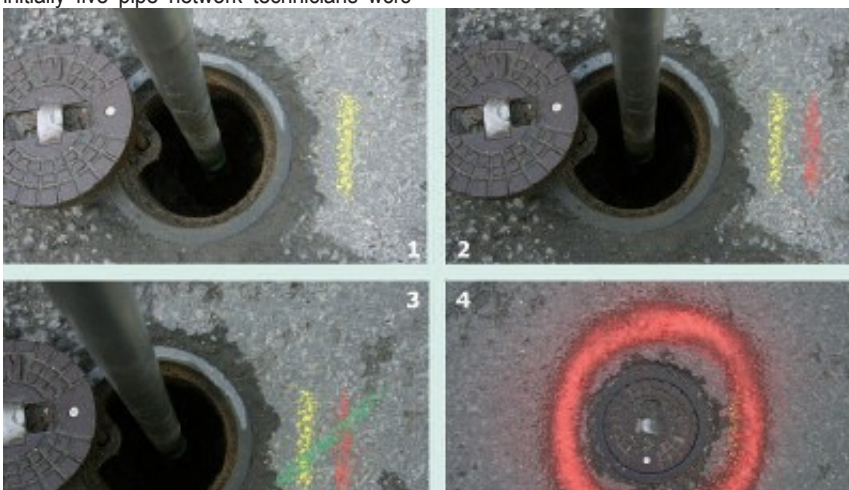
Fig. 3: Marking on road caps

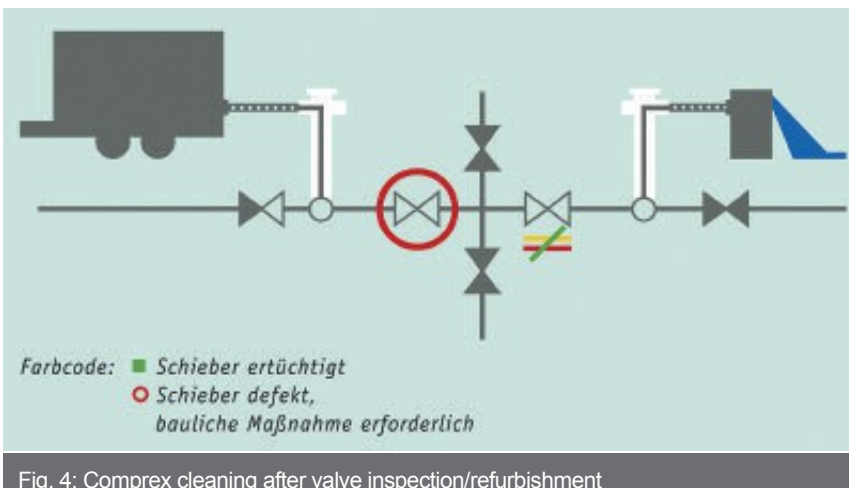
Fig. 4: Complex cleaning after valve inspection/refurbishment

Slides that do not close or close poorly are specifically trained by opening and closing them several times, with the release force of the Comprex process providing support where necessary. Between 50 and 70 percent of the gate valves can be trained in this way. As Comprex cleaning takes place after and during the valve repair, it is ensured that all substances that have been loosened and mobilized from the valves are reliably removed from the pipe network (Fig. 4).
