Cleaning the raw water pipes secures the drinking water supply

Not only the wells must be regularly regenerated, but also the raw water pipes to the waterworks can represent a critical area for operations and may require regular cleaning. Depending on the water quality, cleaning measures should therefore be included in the company organization. Two examples show the effectiveness of the Impuls flushing process (COMprex' process) for upgrading untreated water pipes.

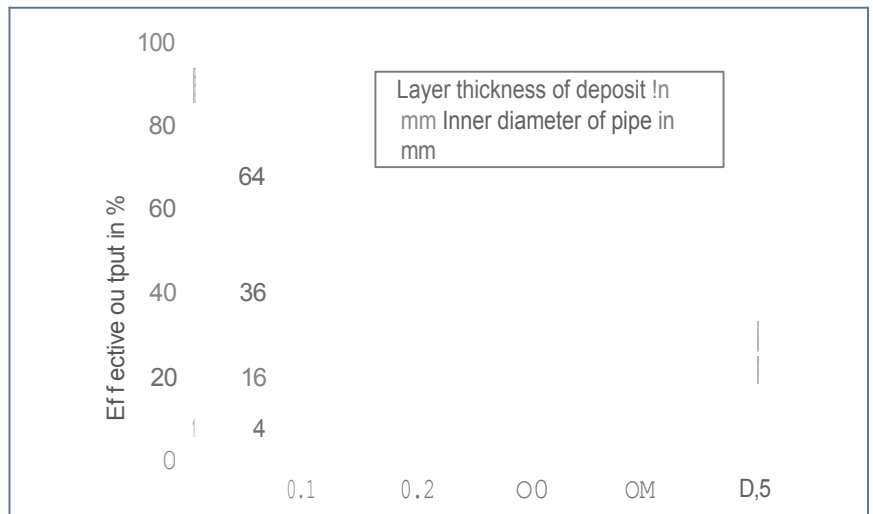
Fig. 1: Cross-sectional narrowing during overgrowth of a pipeline

Figure 1 shows how deposits narrow the cross-section of a pipe. For example, in a pipeline with an internal diameter of 300 mm, a layer thickness of 30 mm reduces the cross-section from 100 to 64 percent. A doubling of this layer thickness to 60 mm reduces the cross-section to 36 percent.

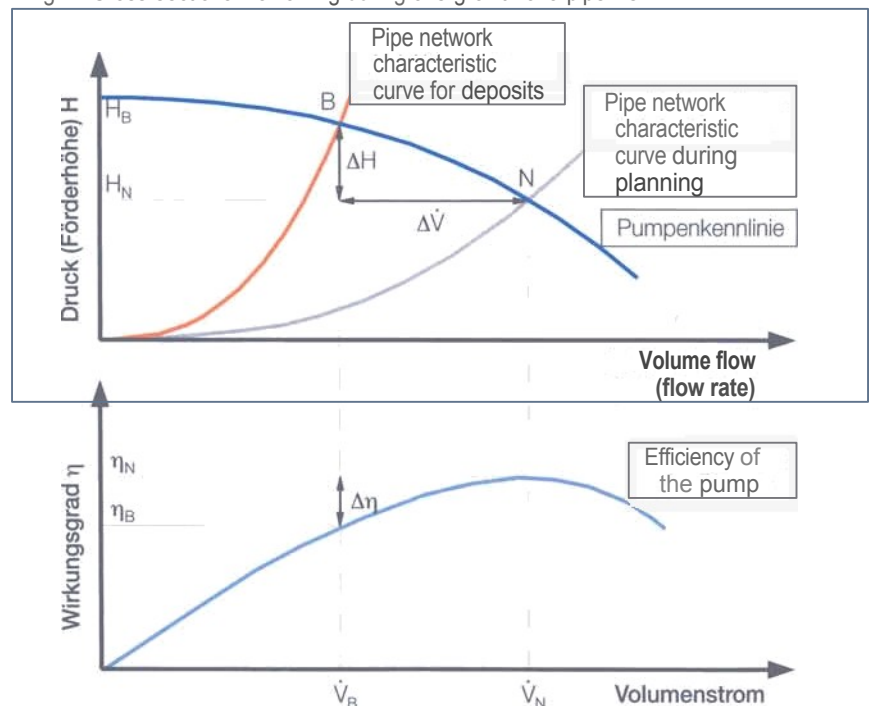
Fig. 2: Pipe line and pump characteristic curve with efficiency of the pump

Both effects influence the piping parameters and therefore the piping curve. Fig. 9.2 shows a piping characteristic curve during the planning of large curves around after bilocation of deposits (red curve). The pump was selected accordingly when planning the piping characteristic curve. The pump characteristic curve (blue curve) intersects the piping characteristic curve at point N. Under these conditions, the pump has its best efficiency η . If the piping parameters change over time, the intersection point of the piping characteristic curve and the pump characteristic curve changes to the point

B. This increases the pump pressure, while the volumetric pressure and efficiency of the pump decrease. The consequences are an increase in energy costs and ultimately an insufficient supply of raw water.

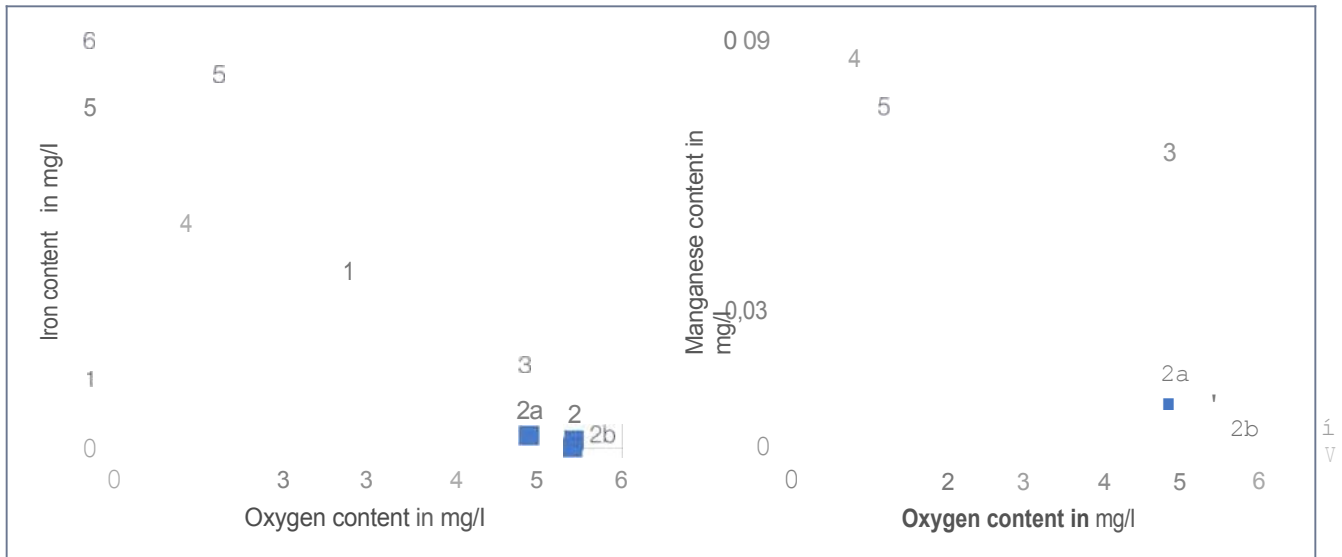
Fig. 7: Relation between oxygen and iron or manganese content in the well water from Piendling and Pösing

The water in the troughs is soft and contains calcium carbonate. They have different oxygen contents. Table 2 indicates a correlation between these parameters. In Figure 7, the values of the well water to the raw water pipe are shown.

Pfendling are shown in blue and those for the raw water pipe Pöding in grey. In the case of the mustard content, a correlation can be seen. In the case of the manganese content, the high value for well 3 in relation to the oxygen content is striking.

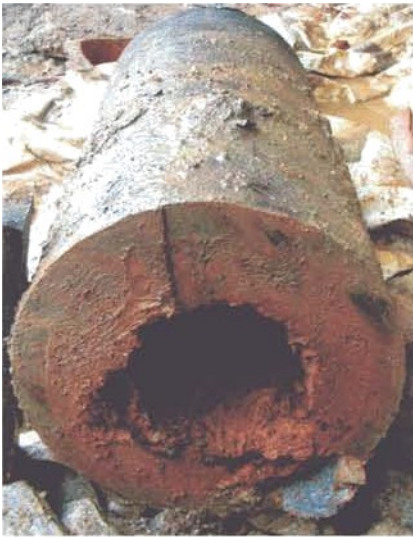
Fig. 9: Deposits in the AZ connection pipe of well 1

The connection pipe at well 1 was also renewed. It consisted of AZ pipes DN 200 (AZ: asbestos cement). Figure 3 shows a pipe section of this pipeline with brown deposits. A mineralogical analysis revealed that these deposits consisted mainly of poorly crystallized ferrihydrite and small but roughly equal amounts of quartz and kaolinite. Ferrihydrite is an oxide/hydroxide of trivalent iron and is formed during the rapid oxidative precipitation of divalent iron dissolved in water at pH values > 5. Other iron oxides e.g. hematite, goethite, lepidocrocite, maghemite or magnetite could not be detected radiographically. The partially fossilized layer was formed over time from quartz sand, the clay mineral kaolinite and the deposited iron compounds.

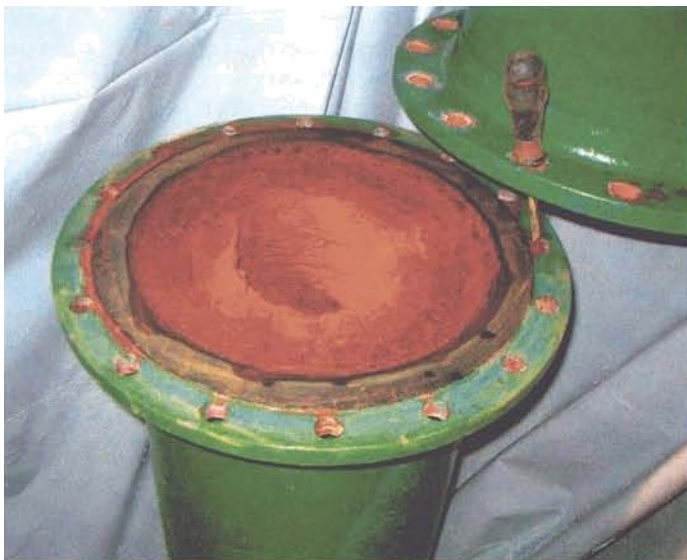
Fig. 10: Deposits in a steel pipe in the waterworks Weather field

The extensive high-pressure cleaning of a 25-metre-long steel pipe in the waterworks upstream of the atomization chamber showed the extent of the deposits (Fig. 10) and the need for cleaning. In terms of process engineering, this procedure was not suitable for the two raw water pipes. The complete renewal was up for discussion.

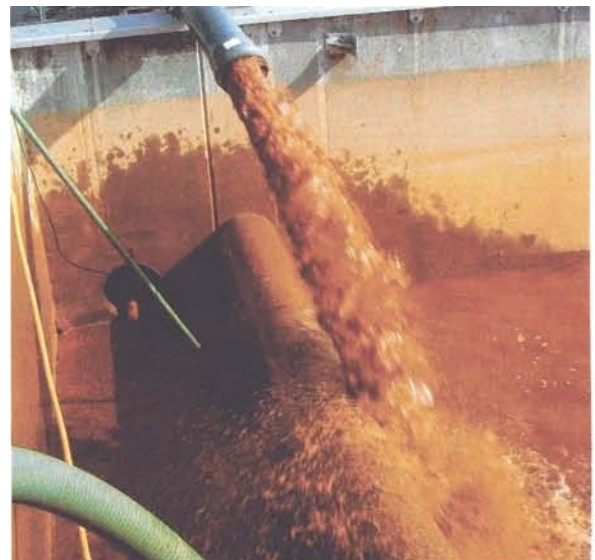
Fig. 1: Removal of ferrous deposits from untreated water pipes in Cham using Complex-VeJahren

The cleaning of the Pöding raw mass separation required four flushing sections. Working around the clock, the sludge was largely discharged after five days (Fig. 11). After flushing, the system values at the well improved

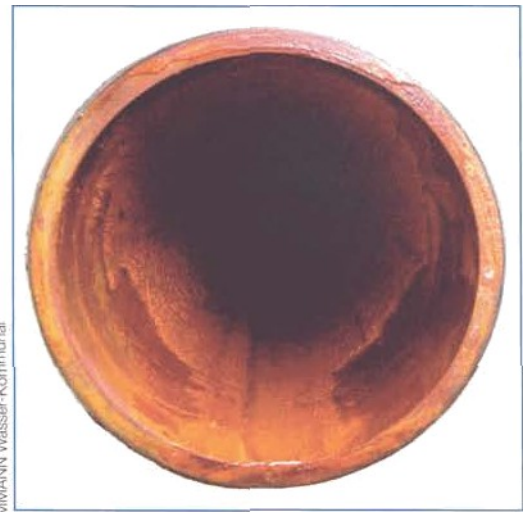
Fig. 13: Pipe section made of DN 350 AZ corrugation after successful pulse flushing

Figure 13 shows the success of cleaning with the Complex process. The few remaining deposits in this AZ pipe DN 350 do not indicate any impairment of the water flow. The inlet pressure at the pumps of wells 1, 2, 2a, 2b and the power consumption are within the normal range.
