S. IMMEL; S. SCHIMMELPFENNIG; N. KLEIN; C. UTKE; R. GNIRSS

Fountain galleries and clean raw water pipes online

Wells are subject to natural ageing processes, as well as deposits and ochre deposits in pipelines water transportation.

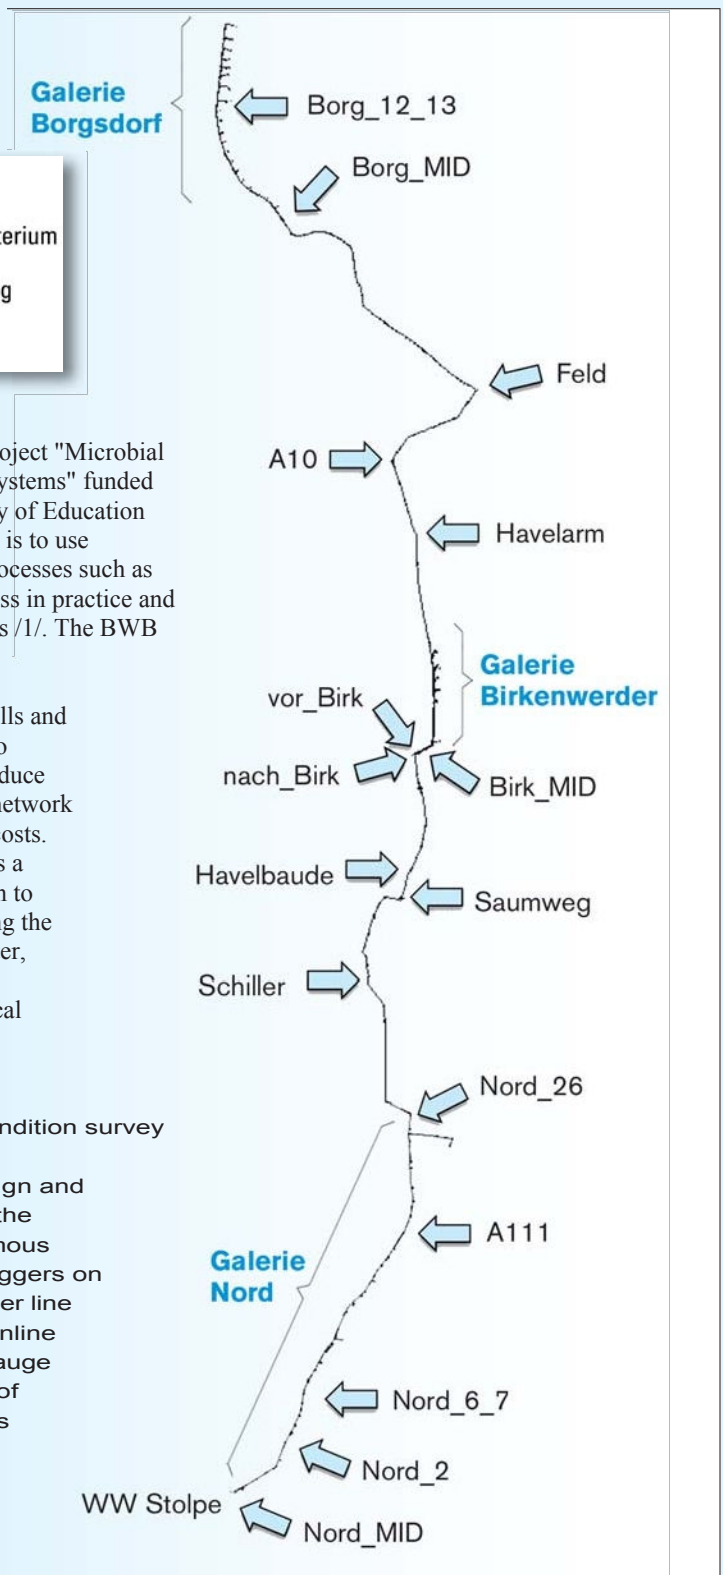
Figure 2 Condition survey during the first campaign and location of the 13 autonomous pressure loggers on the raw water line and the 3 online Pressure gauge at the MID of the galleries

The condition of the pipes after cleaning and the improvement in performance can also be seen. The length of the three galleries and pipe sections, which were measured during the first campaign with 3 online pressure gauges on the EMF and with

13 autonomous pressure loggers are shown in Figure 2 (p. 15).

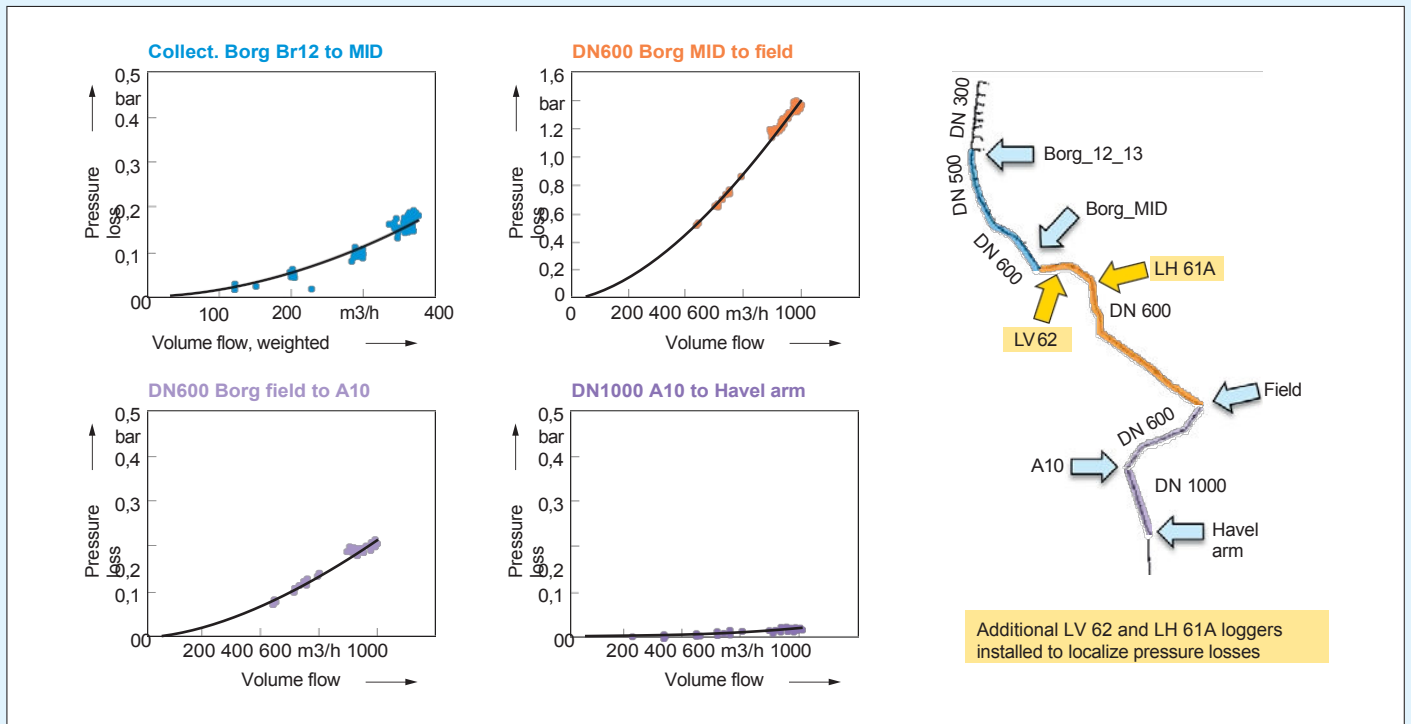
Figure 3 Characteristic curves of the pipeline sections between the Borgsdorf and Birkenwerder galleries, determined in the first campaign

The characteristic curves determined on the pipeline sections between the Borgsdorf and Birkenwerder well galleries can be seen in Fig. 3 (p. 16). Here, a very high pressure loss can be seen in the red DN 600 pipeline section. This is the reason for investigating this section further. The other sections show moderate to no pressure losses.

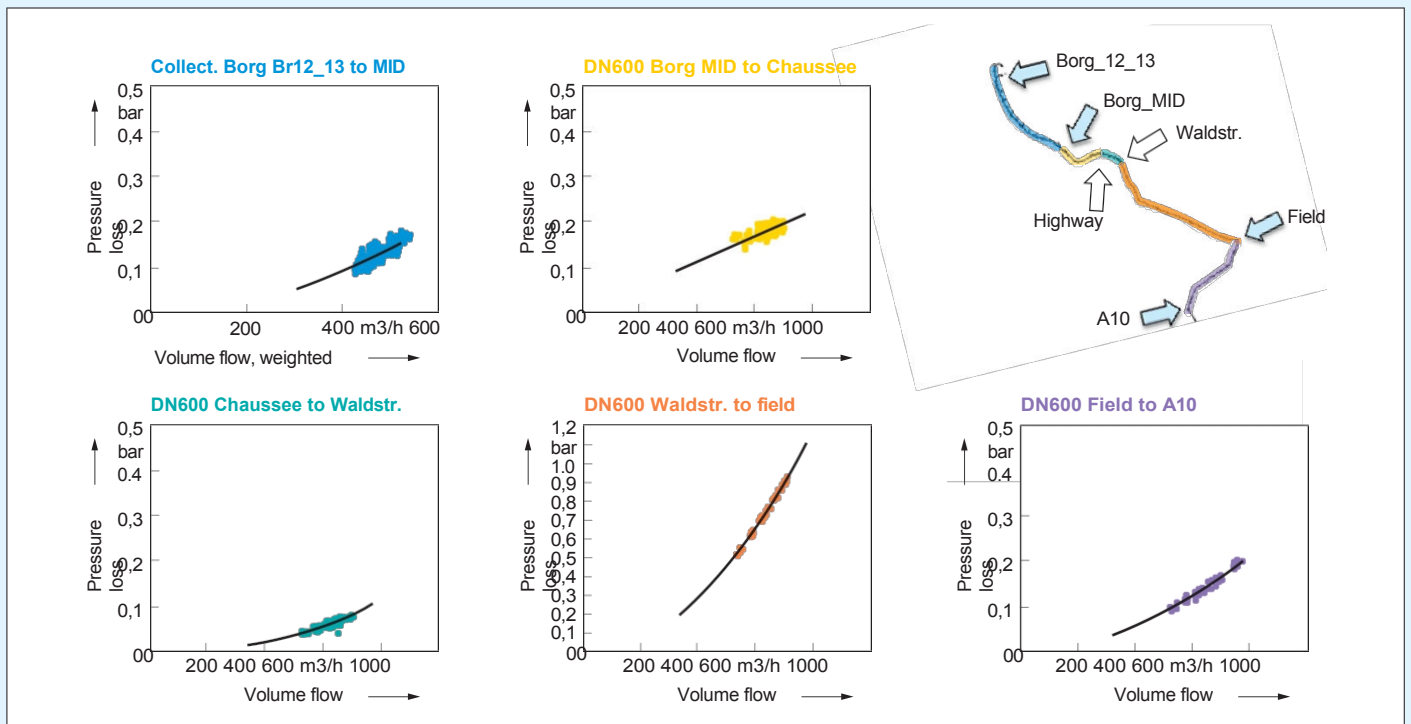
Figure 4 Characteristic curves of the pipeline sections between the Borgsdorf and Birkenwerder galleries, determined in the second campaign

The next step was to find the cause of the high pressure losses in the approximately 1,300 m long DN 600 section. For this purpose, additional pressure loggers were installed on both the main pipes and the well connection pipes in the second campaign. A comparison of the measured pressure losses with calculated target values was used to estimate possible energy savings after the improvement.

Fig. 4 (p. 16) shows the characteristic curves based on the measurements on the 5 pressure loggers. The installation position can be seen from the sketch. A striking feature is the 925 m long section marked in red, which only had a determined nominal width of DN 412 instead of DN 600 hydraulically.

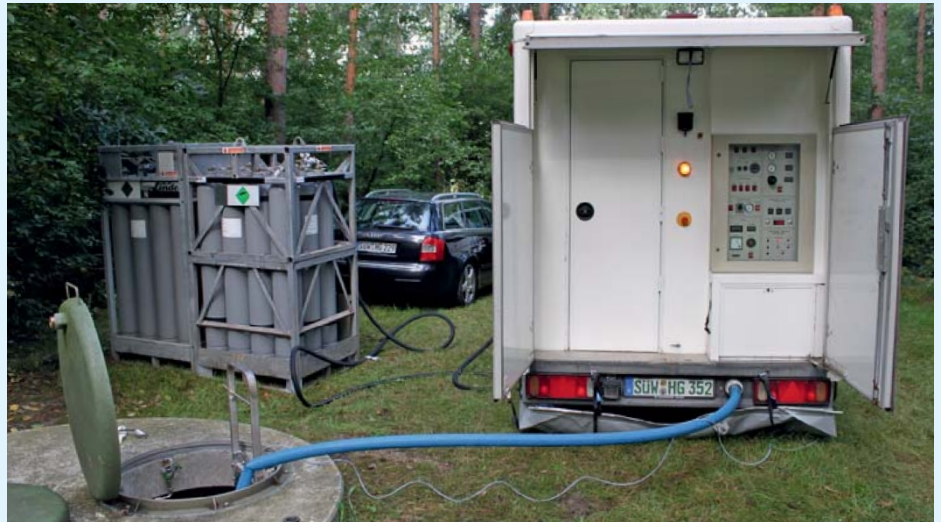
Figure 5 Compressed air and nitrogen feed into the well line controlled by a Complex unit

Foreign matter that interferes with treatment in the waterworks. To clean pipes larger than DN 400, two powerful Complex units are always required to provide enough compressed air to form air and water blocks at short intervals. Two innovative ideas were used for the first time during the two-week project. On the one hand, cylinder batteries with nitrogen replaced the second Complex unit in order to keep the costs for personnel and technology to a minimum. On the other hand, a new control unit enabled the now patent-pending modulation of the pulse output. As part of the project, the working gas was fed into 20 wells and one hydrant on the pipeline (Fig. 5, p. 17).

The nitrogen was fed from the cylinder battery via a pressure reducer directly into the supply tank of the Complex unit, which controlled the pressure pulses (Fig. 5, p. 17). It was shown that nitrogen from a cylinder battery is available more quickly than compressed air from a compressor of a Complex unit. In mathematical terms, the nitrogen support even made it possible to increase the output of a Complex unit by a factor of 2.5. The nitrogen requirement per well connection line amounted to

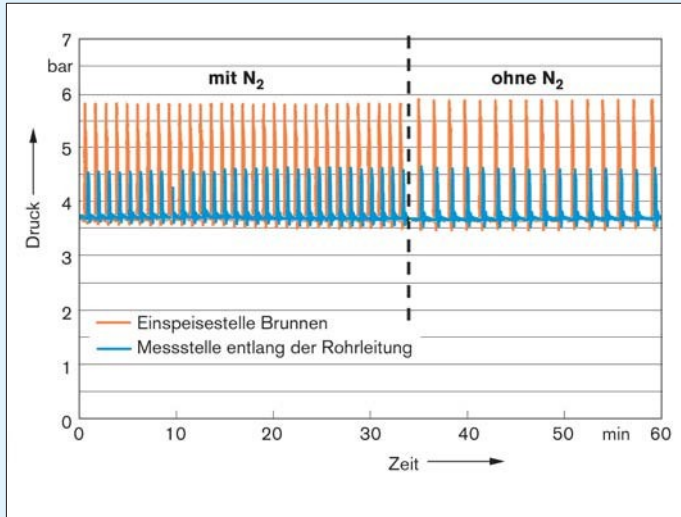
Figure 6 Pressure curve with nitrogen addition to temporarily increase the performance of the Complex procedure and without Nitrogen addition

From the research activities in the BMBF joint project, it is also known that the pressure curve in the cleaning section provides information about the efficiency of the cleaning. This knowledge helped to optimize the setting parameters. For example, it was shown that throttling the volume flow by switching off some pumps increased the effectiveness of the cleaning process. Monitoring with the measuring device developed as part of the BMBF joint project provided the necessary information. The selected settings resulted in air and water blocks between 30 m and 50 m in length. The effect of the additional nitrogen addition is shown in Figure 6.

This required about two batteries with 12 flaps each. One battery was sufficient for around 30 minutes to clean short pipe sections such as well connection pipes (Fig. 6, p. 18). Another Complex unit was added on two days to clean the DN 600 main line. The nitrogen support increased the performance of the two Complex units as much as if 5 Complex units were in use.

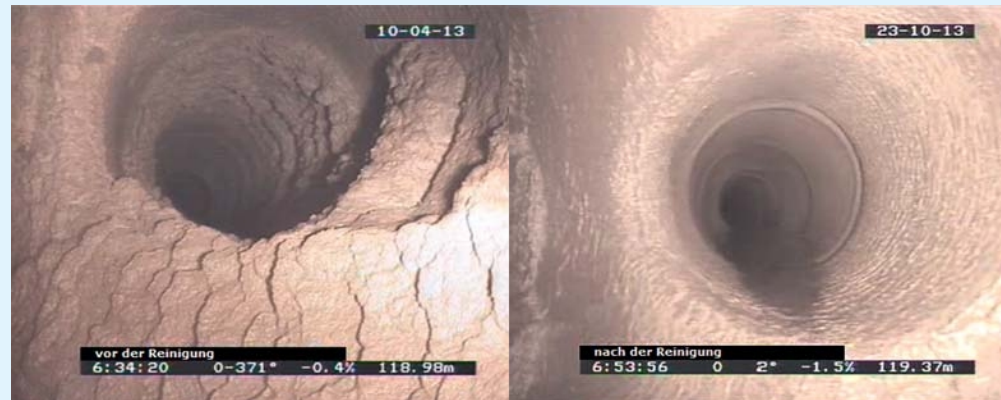
Figure 8 Effectiveness of Complex cleaning on DN 200 well connection pipes
Photo:

The measure showed that Complex cleaning is also possible online with reduced operation of raw water pipes during periods of low demand. The new findings could be put into practice. The performance of the pipes could be increased. Figure 7 (p. 18) shows the theoretical pipeline characteristics as well as the pipeline values determined during performance runs before and after cleaning. Inspection of the pipe section after Complex cleaning also showed a clear improvement, especially on the connecting pipes to the wells (Fig. 8, p. 18).
