Effective network maintenance increases operational reliability

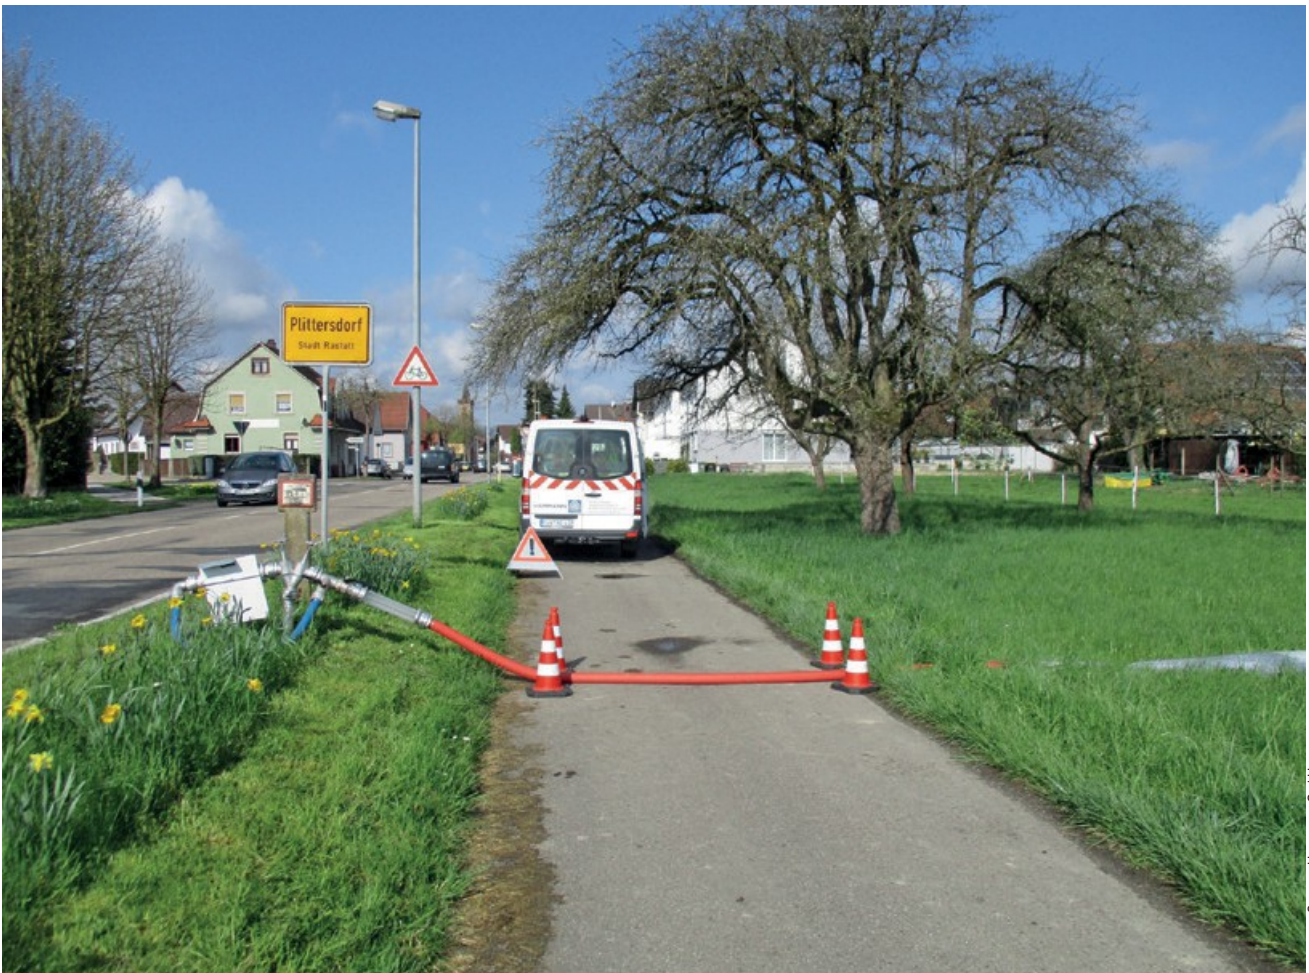
Fig. 1: Complex cleaning in the Rastatt district of Plittersdorf

In March 2016, Hammann GmbH decided to clean its network with the Complex pulse flushing system (Fig. 1).

As the valves are often operated several times during this measure, a systematic check of their function was a good idea. If the inspection at Complex net-care reveals gate valves that do not close, they are repaired or rehabilitated. The measure carried out between March and August 2016 involved 73.6 km of pipes in DN 50 to DN 400 with 1,052 gate valves, one butterfly valve and 782 hydrants.
