Cleaning of municipal drinking water mains in Liechtenstein

Task

- cleaning drinking water pipelines in the Principality of Liechtenstein using the Comprex® procedure
- removing of easily mobilised deposits
- eliminating problems with turbidity
- ensure performance

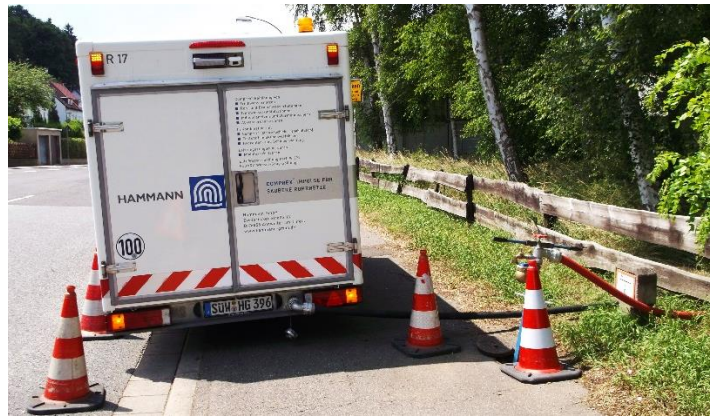
Figure 1: Comprex® equipment on site

- mechanical cleaning procedure using water and treated compressed air supplied by Comprex® unit (Figure 1)
- cleaning in sections using different injection locations along the pipeline
- injection and discharge with adapter connections
- discharge of air and cleaning water with discharge bag (Figure 2 and Figure 3)
- inspection glass at discharge location for indication of cleaning progress (Figure 4)
- 2 technicians, 20 days on site

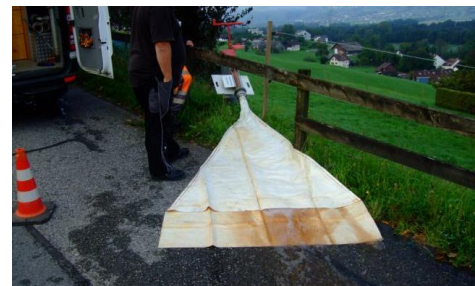
Figure 2: discharge bag

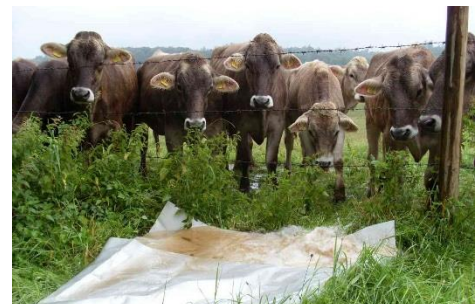
Figure 3: discharge location

- deposits and large particles mobilised and discharged (Figure 3 to Figure 5)
- turbidity eliminated
- improved hydraulic properties
- performance restored

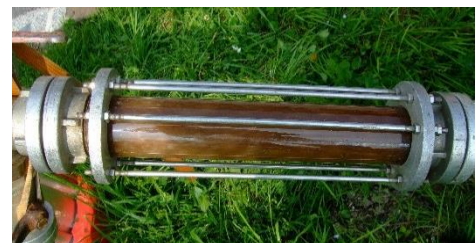
Figure 4: inspection glass during cleaning
