Cleaning of municipal drinking water pipelines in Portugal

Cleaning using the Comprex® procedure

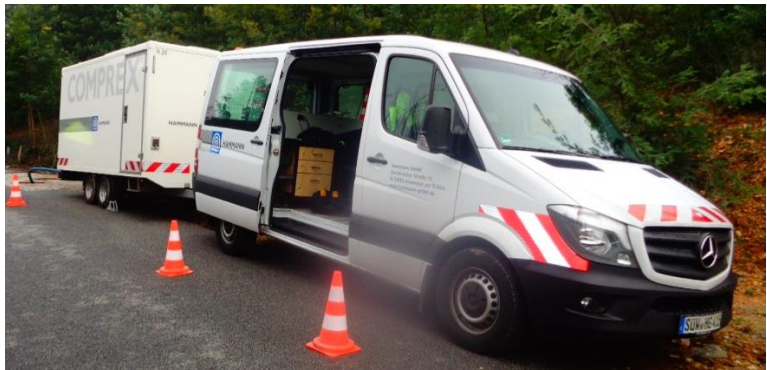
Figure 1: Comprex® equipment at work

- mechanical cleaning process using water and treated compressed air and water delivered by Comprex® unit (Figure 1)
- cleaning in sections by using different injection locations along the pipe (Figure 2)
- discharge using a discharge box (Figure 3)
- inspection glass at the discharge location as indication of the progress of cleaning (Figure 4)
- 1 technician, 3 days on site

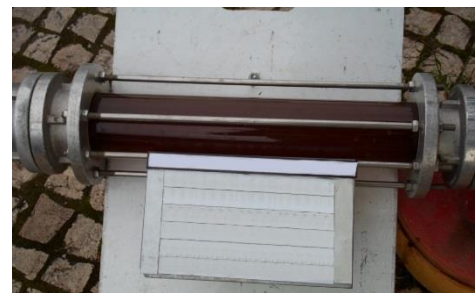
Figure 4: inspection glass during cleaning

- deposits and large particles mobilised and discharged (Figure 3 to Figure 5)
- turbidity eliminated
- improved hydraulic properties due to decreased pressure drop
- performance and security of supply restored
