Reference project

Cooling system**Automotive supplier**

Cleaning of a cooling system with 16 plate heat exchangers

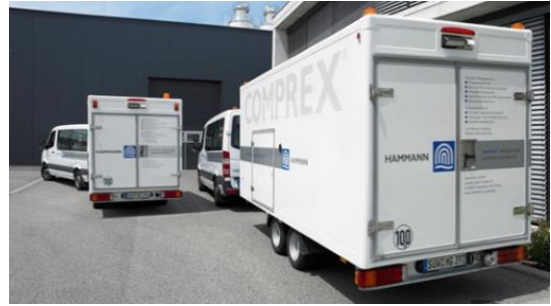
Figure 1: Comprex® units on site

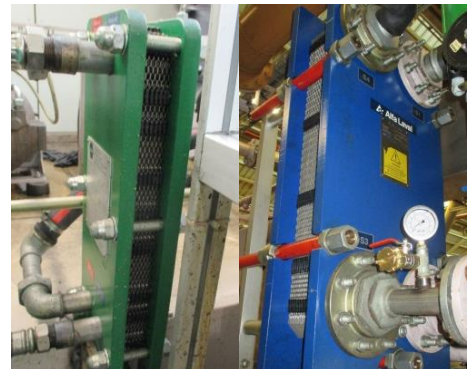
- large cooling system, length approx. 1.200 m
- 16 plate heat exchangers of various dimensions (Figure 2)

Figure 2: plate heat exchangers
in cooling system**Cleaning using the Comprex® process**

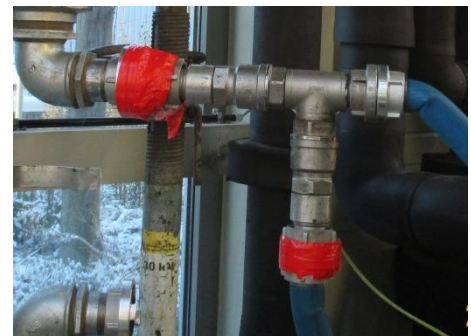
Figure 3: adapters for access
to the system**Result of Comprex® cleaning**

- efficient cleaning of the system by defined application of air and water
- standard adapters for connections between cooling system and Comprex® unit (Figure 3)
- successive procedure of cleaning:
 - 1st step: cleaning of the pipelines without heat exchangers (heat exchanger excluded with bypass)
 - 2nd step: cleaning of the individual heat exchangers (seperated from the pipelines)
- visual monitoring of cleaning progress cleaning via turbidity in inspection glass (Figure 4)
- 2 technicians / engineers
- approx. 40 hours on site

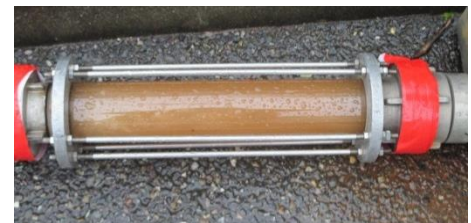
Figure 4: inspection glass for visual
monitoring of the progress of cleaning
