Reference project

**Absorber
Exhibition center**

Comprex® cleaning of a cooling system with absorber in the energy center of an exhibition center

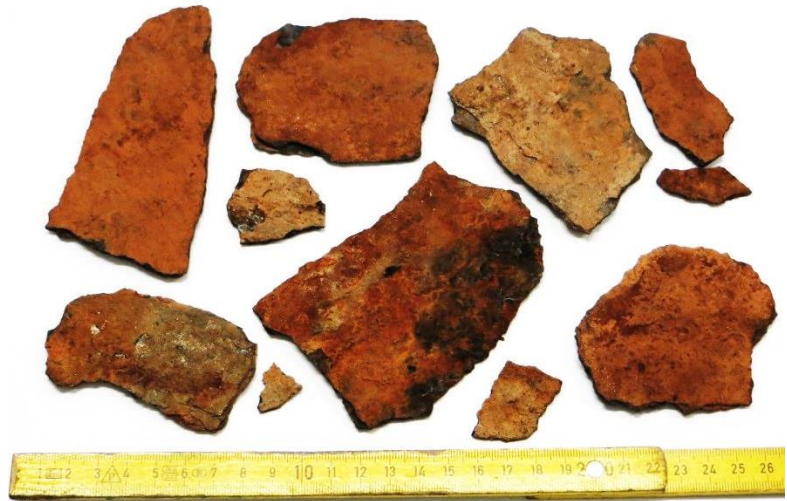
Figure 1: deposits removed from the system

- remove deposits (Figure 1) from the system
- clean an absorber (Figure 2) and feed / discharge lines of the cooling system
- recover performance, safety and reliability of the system

- deposits mobilized and discharged (Figure 1 and Figure 4)
- increased performance
- improved safety and reliability
- efficient operation

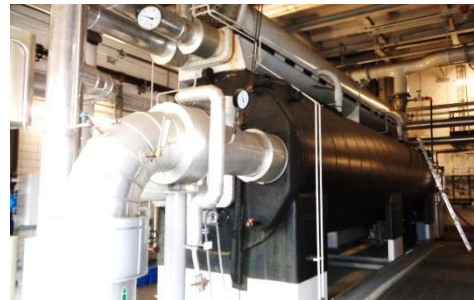
Figure 2: absorber (Shell and tube heat exchanger) in cooling center

- pipelines up to DN 400, length approx. 60 m
- absorber (shell and tube heat exchanger): length 8 m, diameter 1,6 m
- permitted pressure of system approx. 10 bar

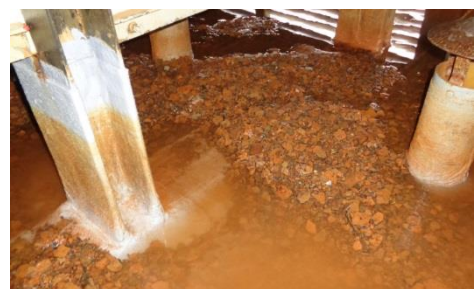
Figure 4: discharge of air, water and removed deposits into cooling tower pond

- efficient cleaning of pipelines and absorber by defined application of air and water
- access to the system via standard adapters (Figure 3)
- discharge into cooling tower pond (Figure 4)
- application of 2 Comprex® units
- 2 technicians, approx. 36 hours on site
