**Treatment of cooling  
lubricants  
Automotive industry**

## Cleaning of plate heat exchangers in a cooling lubricants treatment plant

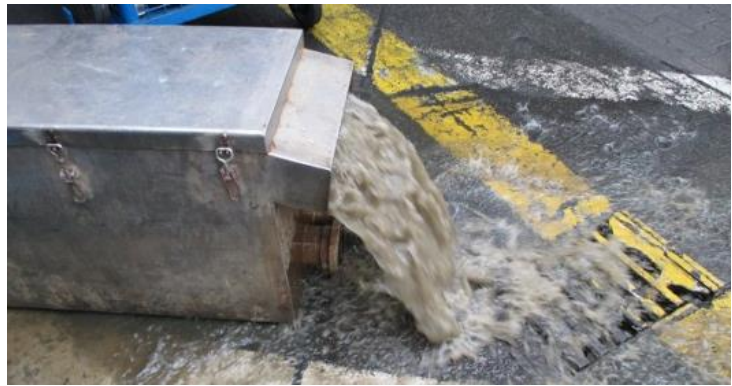
Figure 1: turbidity at discharge point

- clean heat exchangers with Comprex®
- remove deposits and impurities (Figure 1)
- recover performance, safety and reliability by improved cooling performance.
- pressure test before and after cleaning

- deposits and impurities have been mobilized and discharged (Figure 1 and Figure 4)
- recovery of cooling performance
- improves safety and reliability of process
- pressure and leakness test

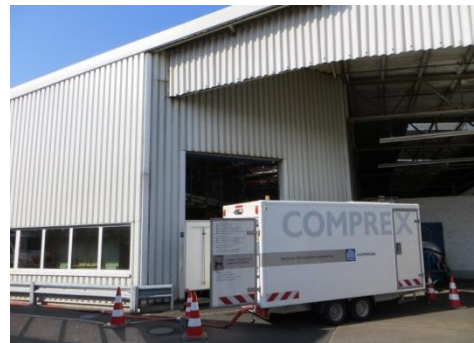
Figure 2: Comprex® unit on duty

- Comprex® unit positioned outside the building (Figure 2)
- entirely mechanical cleaning using air and water of an installed device (Figure 3)
- access to heat exchangers via standard adapters
- visual monitoring of cleaning effect via turbidity in inspection glass (Figure 4)
- 2 technicians, approx. 10 hours on site

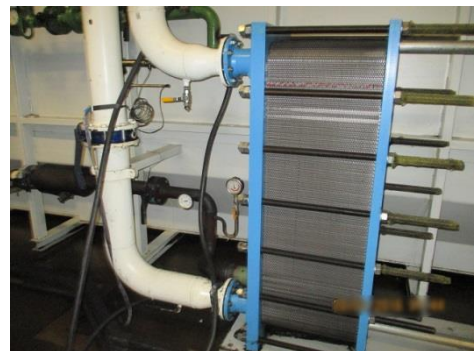
Figure 3: heat exchanger during cleaning

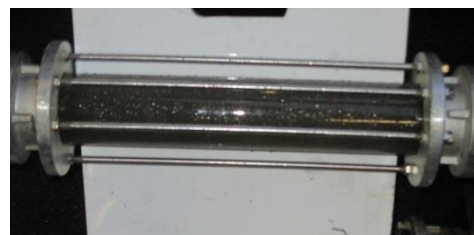
Abbildung 4: turbidity in inspection glass
