Comprex® cleaning
Raw water pipes

Reference project
Stadtwerke Heppenheim
(Germany)

Cleaning two well pipes connected to the waterworks

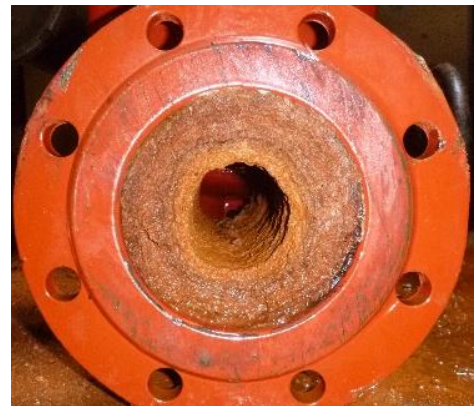
Figure 2: Condition of pipe before cleaning

- cleaning iron ochre precipitations from raw water pipes with Comprex®
- removal of massive iron and manganese residuals from the pipes (figure 2)
- restore original condition of pipe diameter
- ensure operating efficacy
- improve energy efficiency

- effective mobilisation and removal of residues for the most parts (predominantly iron and manganese sludge)
- total removal of approx. 10 m³ solids from the pipes
- restored operating efficiency almost equal to as-new condition
- improved hydraulics power due to minor pressure loss
- efficient pump operation

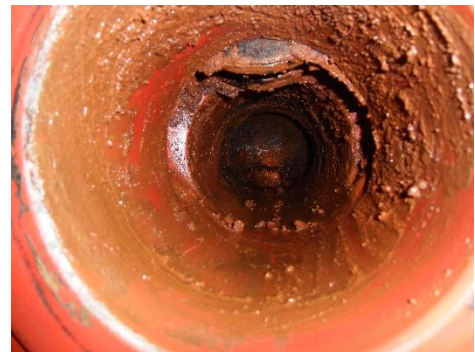
Figure 3: Condition of pipe post-cleaning

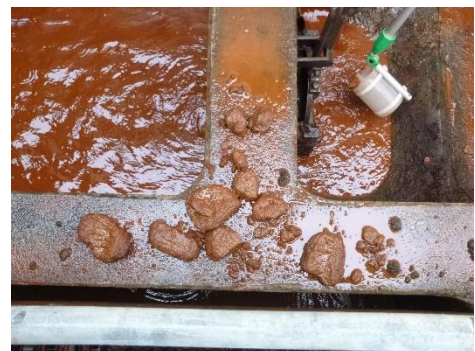
Figure 4: Water outlet at settling tank

- mechanical cleaning based on specific implementations of compressed air and water
- cleaning water feed-in via well
- cleaning water outlet via settling tank at the waterworks (figure 4)
- 1 technician, 18 on-site working hours
