Reference project

**Fire water systems  
Logistics and  
transport company**

## Cleaning of several fire water systems including sprinkler systems

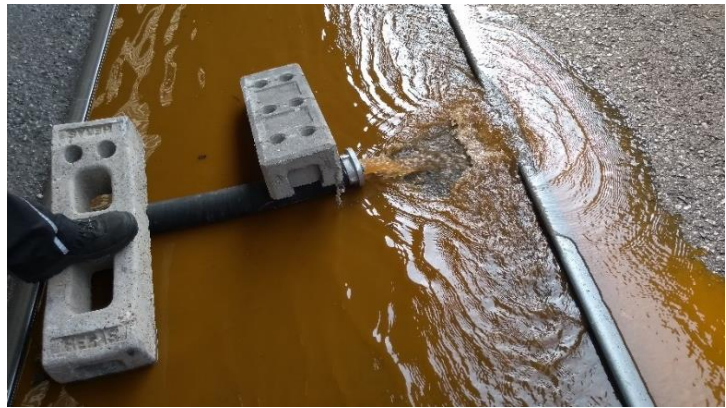
System Figure 1: Discharge from the system

- Sediments mobilized and discharged (Figure 1, Figure 3 and Figure 4)
- Lower pressure loss, increased energy efficiency
- Improved performance and operational reliability
- Expert inspection 2019: no hydraulic complaints

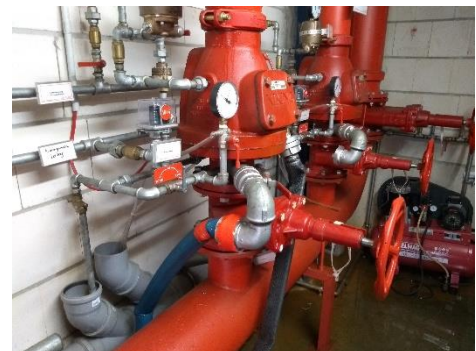
Figure 2: Access to system via standardized adapter connections

- Mechanical cleaning through the controlled use of compressed, treated air from Comprex® unit
- Access to the system via standardized adapter connections (Figure 2)
- Systematic cleaning of the individual subsystems
- 3 technicians / engineers, approx. 4 days on site

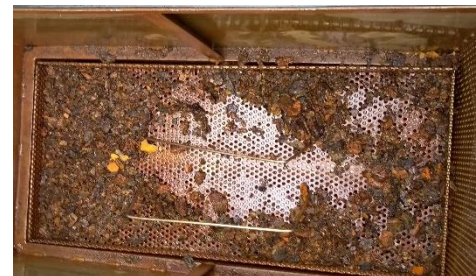
Figure 3: Large particle discharge from subsystem

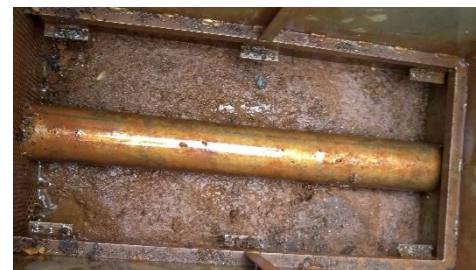
Figure 4: Fine particle discharge from subsystem
