## Cleaning of municipal drinking water pipelines in Portugal

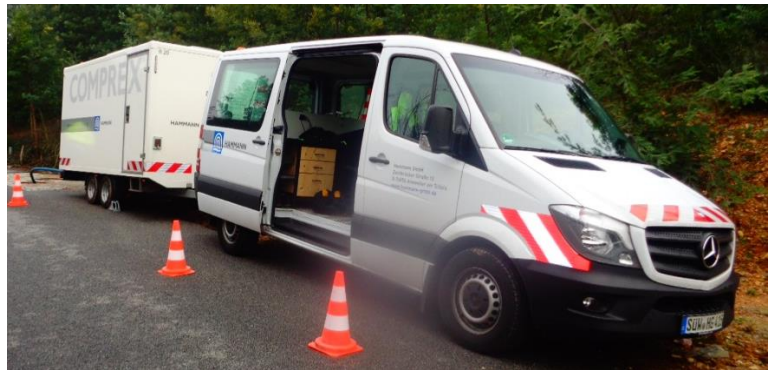
Figure 1: Comprex® equipment at work

- mechanical cleaning process using water and treated compressed air and water delivered by Comprex® unit (Figure 1)
- cleaning in sections by using different injection locations along the pipe (Figure 2)
- discharge using a discharge box (Figure 3)
- inspection glass at the discharge location as indication of the progress of cleaning (Figure 4)
- 1 technician, 3 days on site

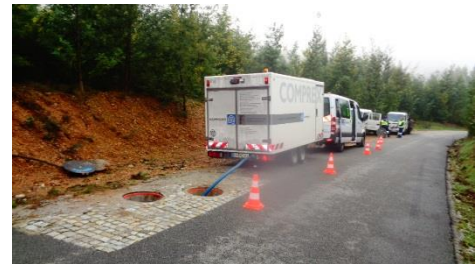
Figure 2: injection location

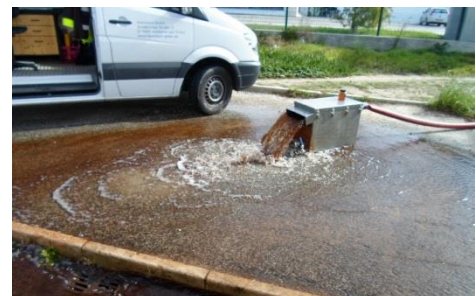
Figure 3: turbidity at discharge box

- deposits and large particles mobilised and discharged (Figure 3 to Figure 5)
- turbidity eliminated
- improved hydraulic properties due to decreased pressure drop
- performance and security of supply restored

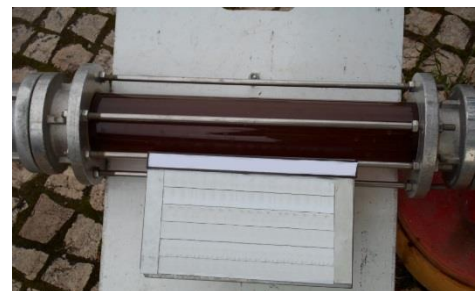
Figure 4: inspection glass during cleaning

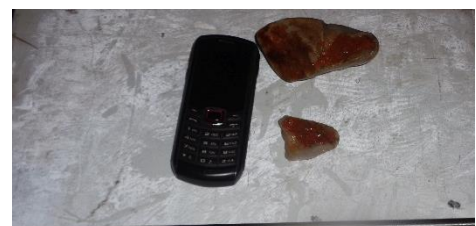
Figure 5: large particles removed from the pipe
