Cleaning a drinking water distribution network in Scotland

Task

- cleaning drinking water distribution network of a large Scottish city using the Comprex® process
- removing of easily mobilised deposits
- eliminating problems with turbidity
- realisation of all works during night time

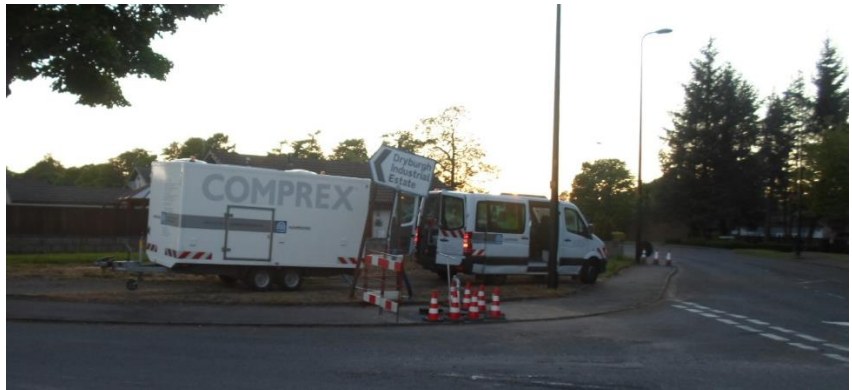
Figure 1: Comprex® equipment on site

- mechanical cleaning process using water and treated compressed air delivered by Comprex® unit (Figure 1)
- cleaning in sections using different injection locations along the pipe network
- injection using adapter connections at hydrant stand pipes (Figure 2)
- inspection glass for indication of cleaning progress at the discharge location (Figure 3)
- measurement of turbidity by our customer for detailed documentation (Figure 4)
- 2 technicians, 12 nights on site

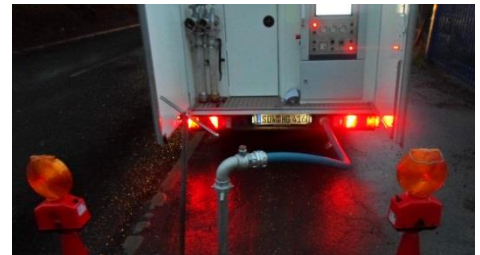
Figure 2: injection using hydrant and stand pipe

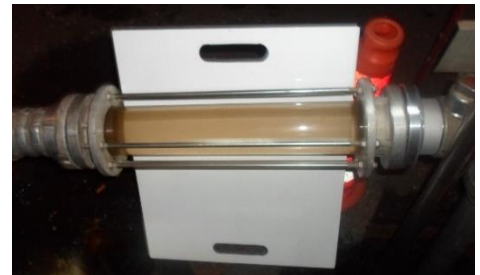
Figure 3: turbidity in inspection glass during cleaning process

- deposits and large particles mobilised and removed (Figure 3 to Figure 5)
- turbidity eliminated
- improved hydraulic properties due to decreased pressure drop
- performance and security of supply restored

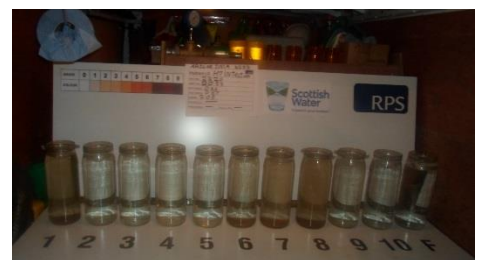
Figure 4: measurement of turbidity during cleaning

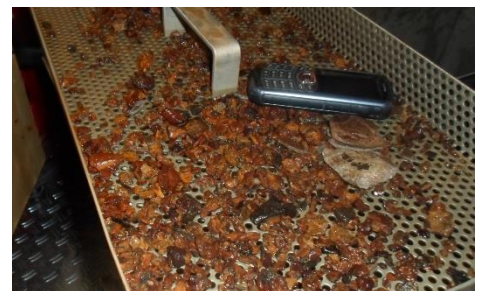
Figure 5: discharged large particles
