Comprex® cleaning  
Raw water pipes

Reference project  
**Stadtwerke Heppenheim**  
**(Germany)**

## Cleaning two well pipes connected to the waterworks

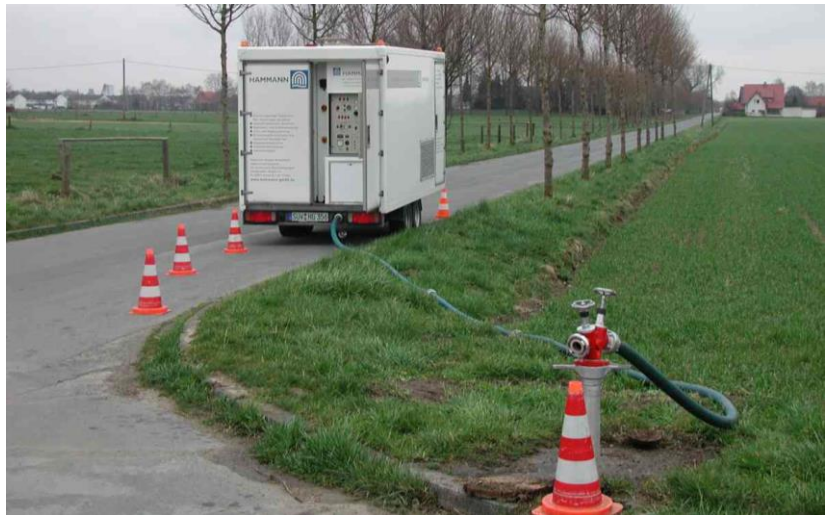
Figure 1: Comprex® unit in action (symbolic imaged)

- mechanical cleaning based on specific implementations of compressed air and water
- cleaning water feed-in via well
- cleaning water outlet via settling tank at the waterworks (figure 4)
- 1 technician, 18 on-site working hours

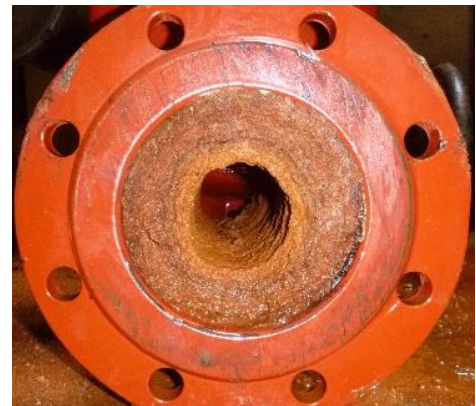
Figure 2: Condition of pipe before cleaning

- cleaning iron ochre precipitations from raw water pipes with Comprex®
- removal of massive iron and manganese residuals from the pipes (figure 2)
- restore original condition of pipe diameter
- ensure operating efficacy
- improve energy efficiency

- effective mobilisation and removal of residues for the most parts (predominantly iron and manganese sludge)
- total removal of approx. 10 m<sup>3</sup> solids from the pipes
- restored operating efficiency almost equal to as-new condition
- improved hydraulics power due to minor pressure loss
- efficient pump operation

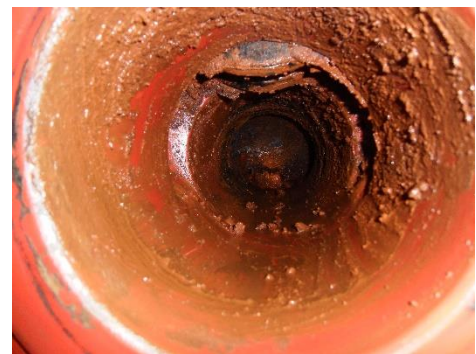
Figure 3: Condition of pipe post-cleaning

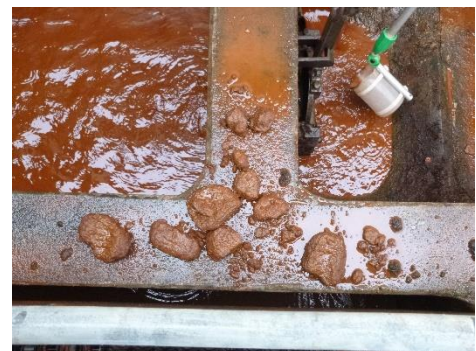
Figure 4: Water outlet at settling tank
